日本博物館災害防制措施：  
汲取於阪神・淡路大地震、  
東日本大地震及大海嘯的經驗教訓<sup>2</sup>

Disaster Preparedness Measures at Japanese Museums:  
Building on the Lessons of the Great Hanshin-Awaji  
Earthquake, Great East Japan Earthquake and Ensuing Giant  
Tsunami

Yujiro Ochi

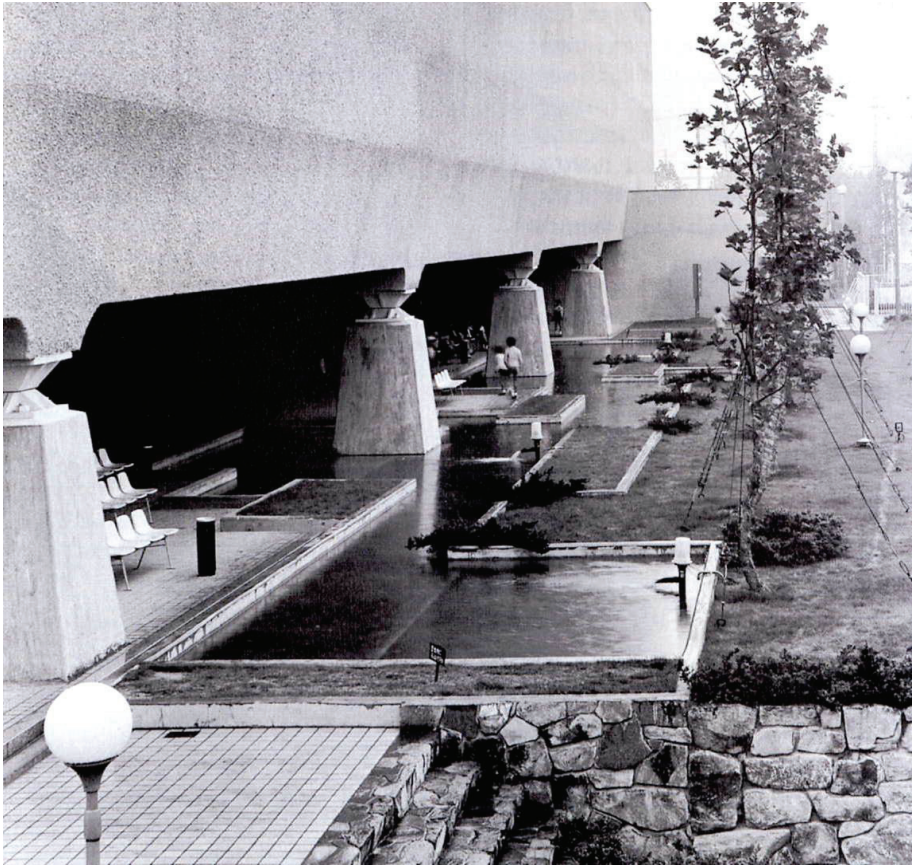
The building itself was heavily damaged. The museum had been built in 1970 primarily as a venue for exhibiting sculpture, and the ground-floor gallery was constructed to let in large amounts of natural light and maximize the skeleton were positioned outside the gallery, and there were only slender columns inside

Fig 1. Thick columns in outside gallery, The Hyogo Prefectural Museum of Modern Art  
(Copyright: The Hyogo Prefectural Museum of Modern Art )

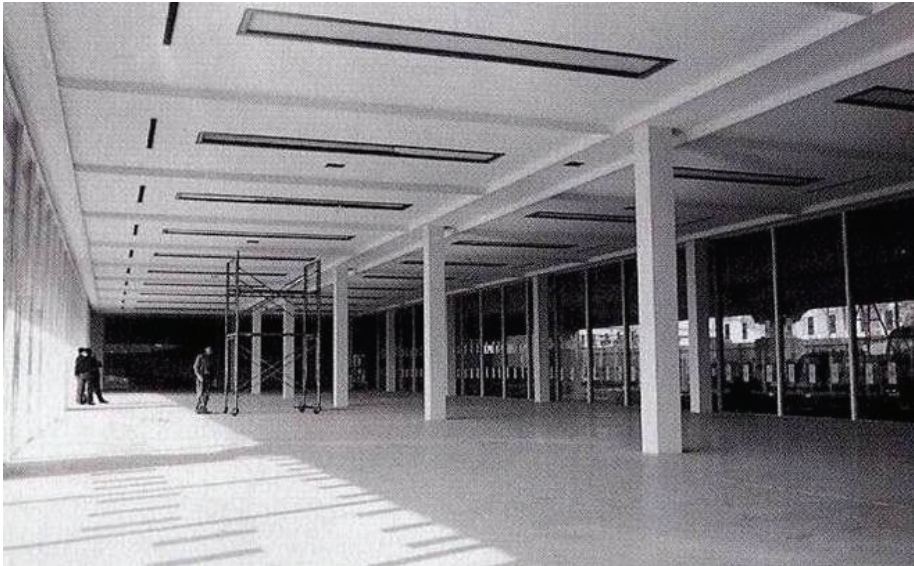
the gallery. This gallery measured 1,000 square meters and had glass walls on either side, with another 800-square-meter gallery on the second floor that contained no columns at all. Due to this design, the roof practically caved in and there was severe damage to the glass.

Fig. 2 Slender columns inside the ground-floor gallery, The Hyogo Prefectural Museum of Modern Art (Copyright: The Hyogo Prefectural Museum of Modern Art)

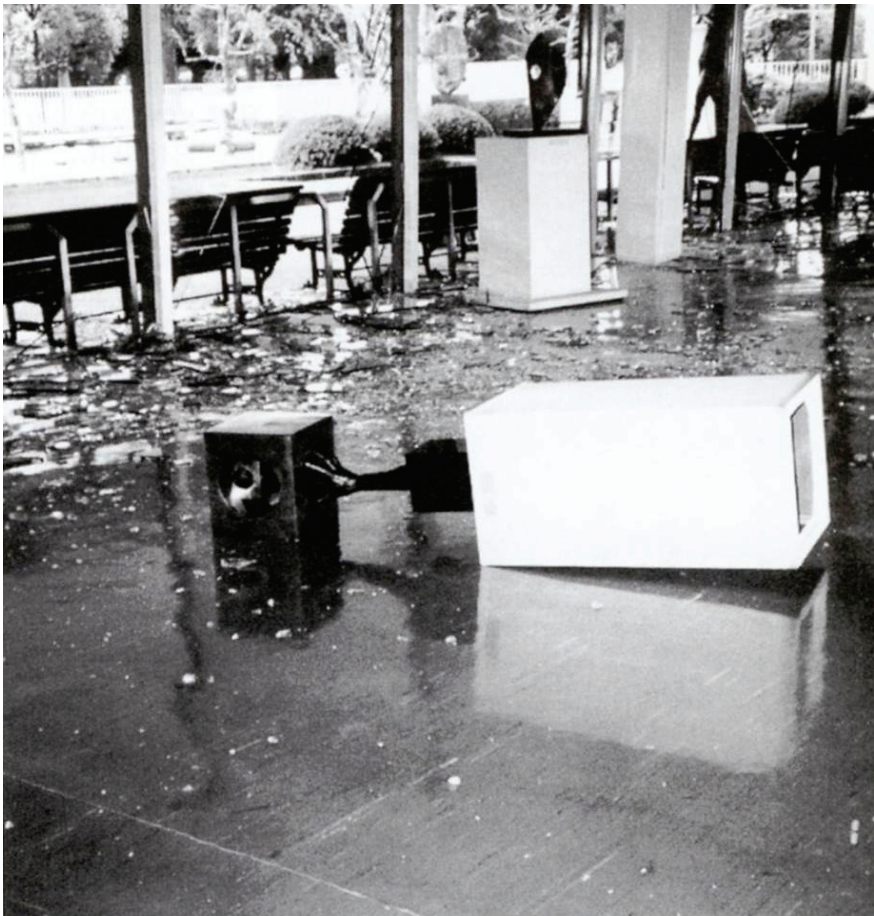
In the galleries, sculptures tipped over and paintings fell from the walls.

Fig. 3 Exhibition room on the ground floor, The Hyogo Prefectural Museum of Modern Art (Copyright: The Hyogo Prefectural Museum of Modern Art from “Report of Investigation for Museums in the Great Hanshin-Awaji Earthquake I / II”)

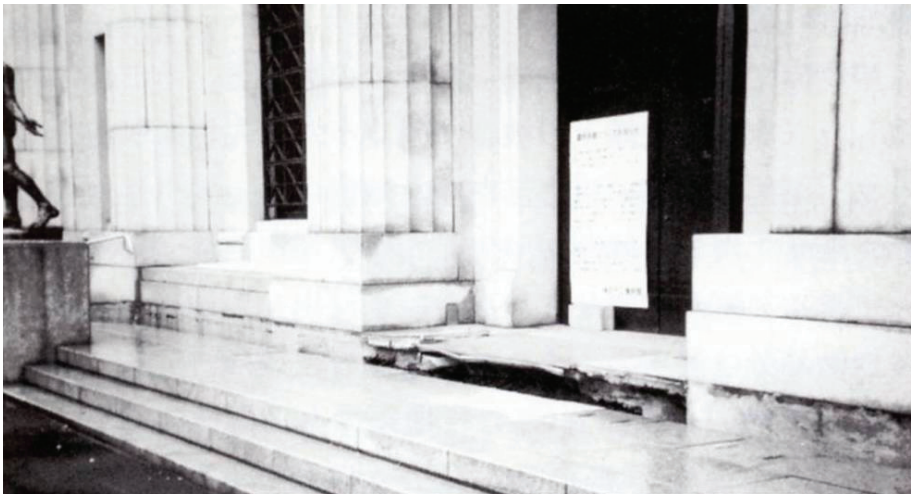
The Kobe City Museum building tilted westward at a five-degree angle, and a crack ran up to the third floor at the place where the main building was joined to the new wing. Water also flooded the basement nearly to the ceiling.

Fig. 4 The building tilted westward at a 5-degree angle, The Kobe City Museum (Copyright: The Kobe City Museum from “Report of Investigation for Museums in the Great Hanshin-Awaji Earthquake I / II”)

However, there was no major damage to the building. The five-degree tilt was corrected, repairs were made, and the museum continues operating to this day. This is evidence that the building, dating back to 1930, was designed to be structurally sound.

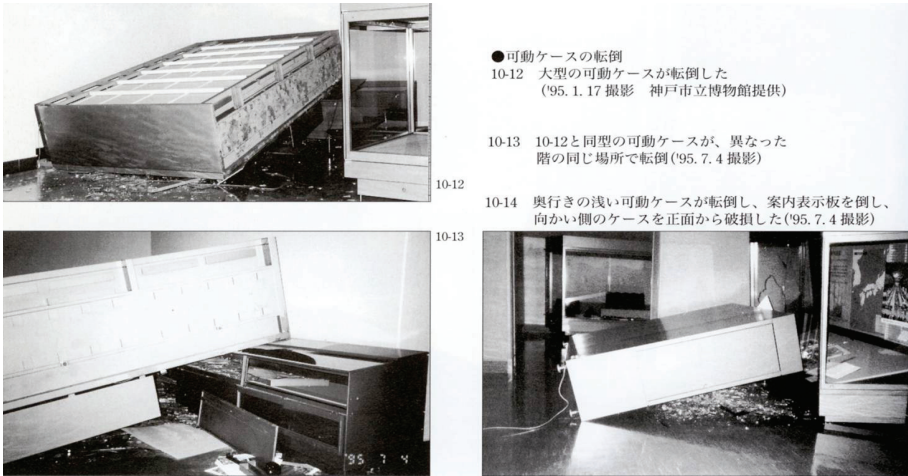
Many display cases, weighing approximately one ton each, shifted by about a meter, and it's likely that this would have injured museum visitors if it had happened during museum hours. Some sculptures, despite supposedly effective preventive measures having been taken to prevent earthquake damage, had the

Fig. 5 Display cases moved in exhibition room, The Kobe City Museum (Copyright: The Kobe City Museum from “Report of Investigation for Museums in the Great Hanshin-Awaji Earthquake I / II”)

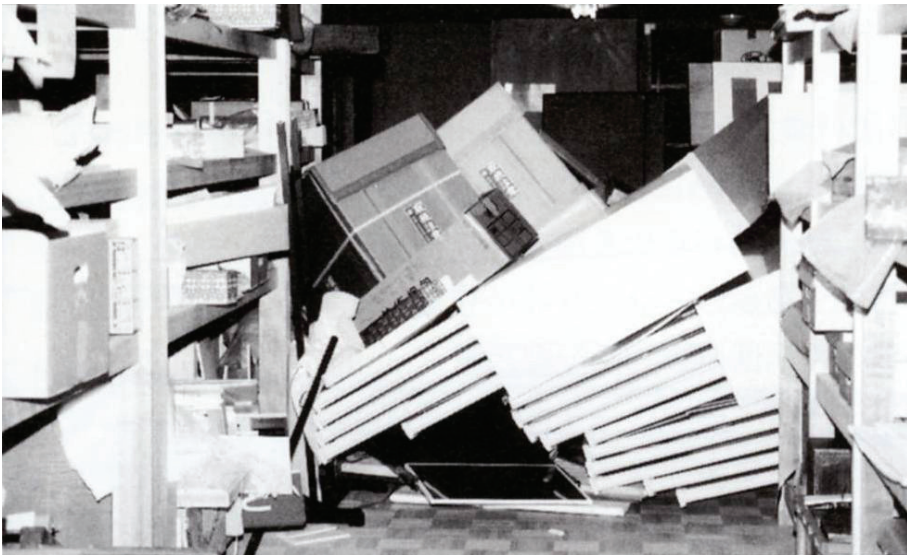
Fig. 6 Storage room, The Kobe City Museum (Copyright: The Kobe City Museum from “Report of Investigation for Museums in the Great Hanshin-Awaji Earthquake I / II”)

Shelves in the storage area tilted drastically. Despite predictions that the art in storage would be severely damaged, those stored in the traditional Japanese manner prevalent since the Edo Period (1603-1868), in inner boxes housed in outer boxes made of Paulownia wood, were completely unharmed. This prompted a reassessment of this traditional storage method and renewed recognition of its efficacy. Naturally, items such as dishes that were simply placed on storage shelves broke when the shelves tilted over.

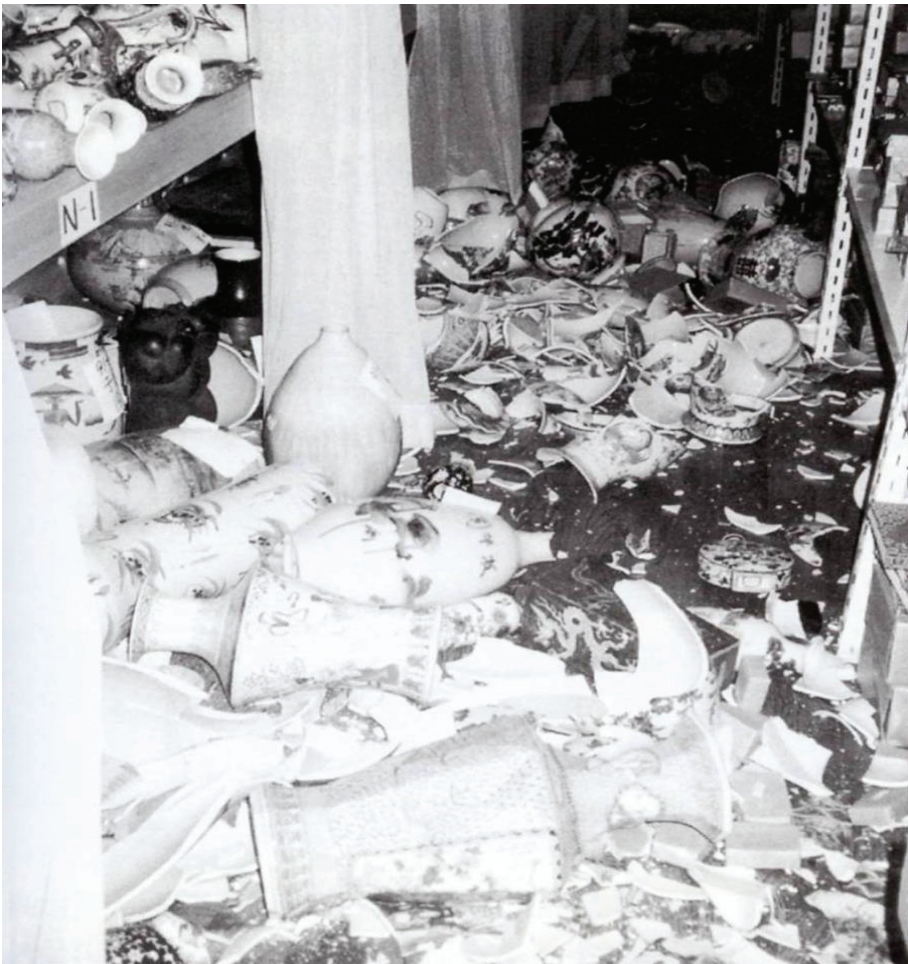
Most of the Chinese ceramics in storage were damaged.

Fig. 7 Storage room, The Emba Museum of Chinese Modern Art (Copyright: The Emba Museum of Chinese Modern Art from “Report of Investigation for Museums in the Great Hanshin-Awaji Earthquake I/II”)

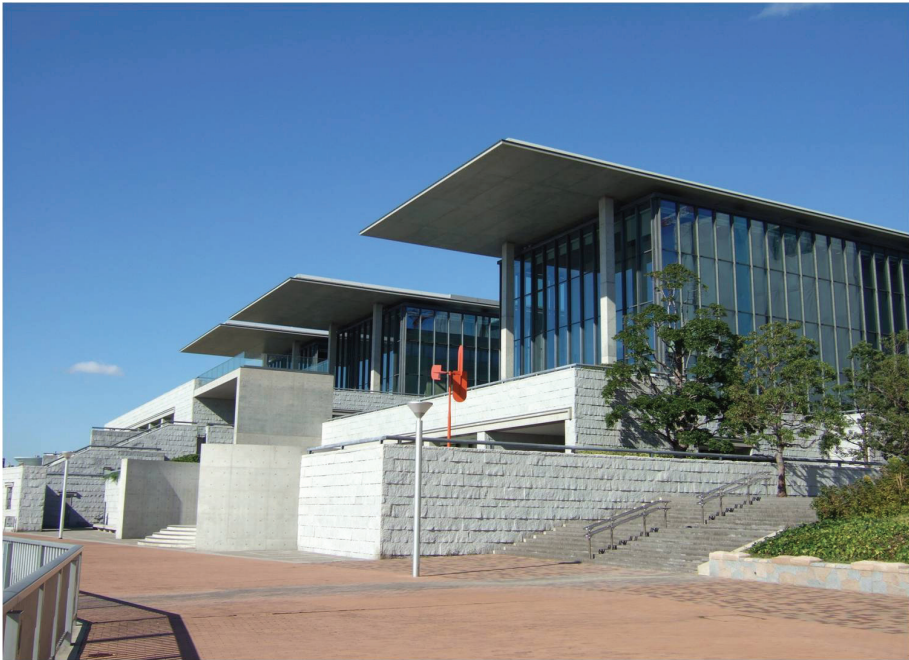
Fig. 8 The new building of The Hyogo Prefectural Museum of Art with Seismic Isolated Structure by Tadao Ando (Copyright: The Hyogo Prefectural Museum of Art)

The Hyogo Prefectural Museum constructed a new, seismically resistant building and moved there seven years after the quake.

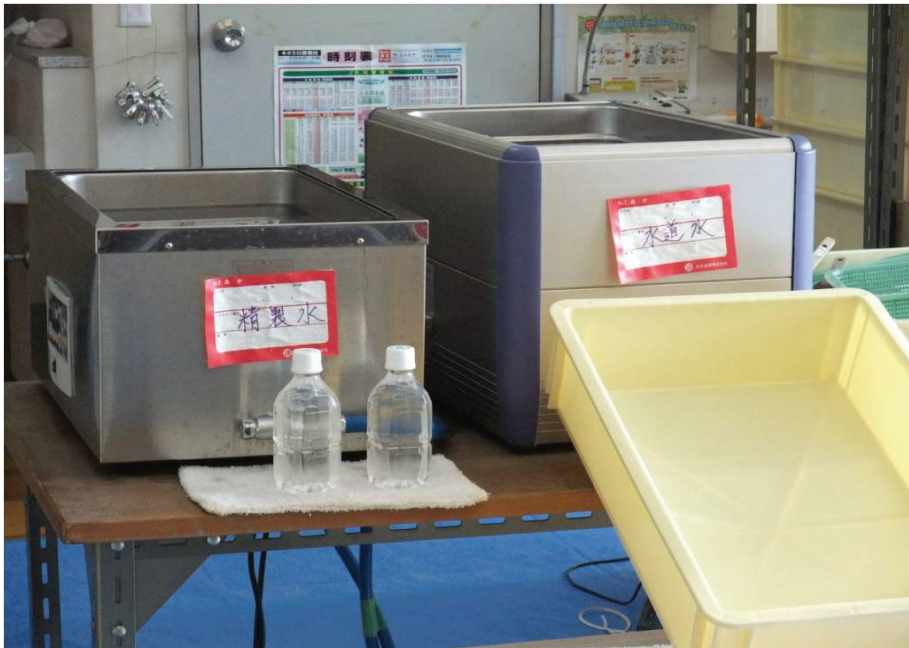
Fig. 9 The items first had to be rinsed gently in tap water (right), and then in purified water (left) (Copyright: The Rikuzentakada Municipal Museum)

There happened to be an elementary school that had just ceased operating at the end of March, and the school building served as a venue for the restoration of the exhibits, or more accurately the preliminary stabilization work before the restoration. The liquid that had soaked the items was more sludge than seawater, and to wash this out, the items first had to be rinsed gently in tap water, and then in purified water. The seashells and other objects were disinfected using ethanol.
